Tests Report

| Proposal ID: | PSO160/2025 |
| Report ID: | PSR0160/2025 – 3 rd version Cancels and replaces report PSR160/2025 – 2 nd version issued on 21/04/2025 |

Determination of the multiaxial impact behavior of three plate samples provided by the client with the following references (Figure 1):

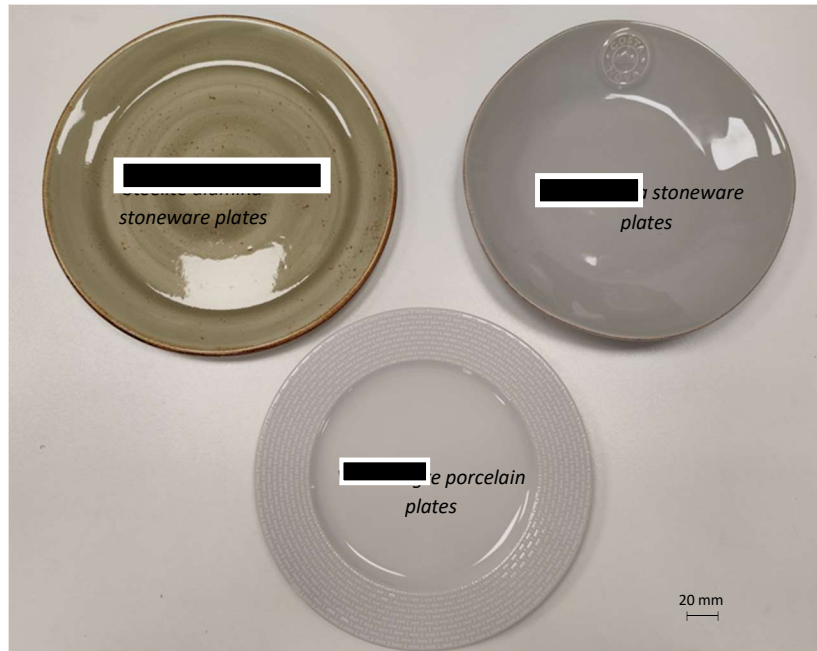
Figure 1 – Plate samples provided by the client for analysis

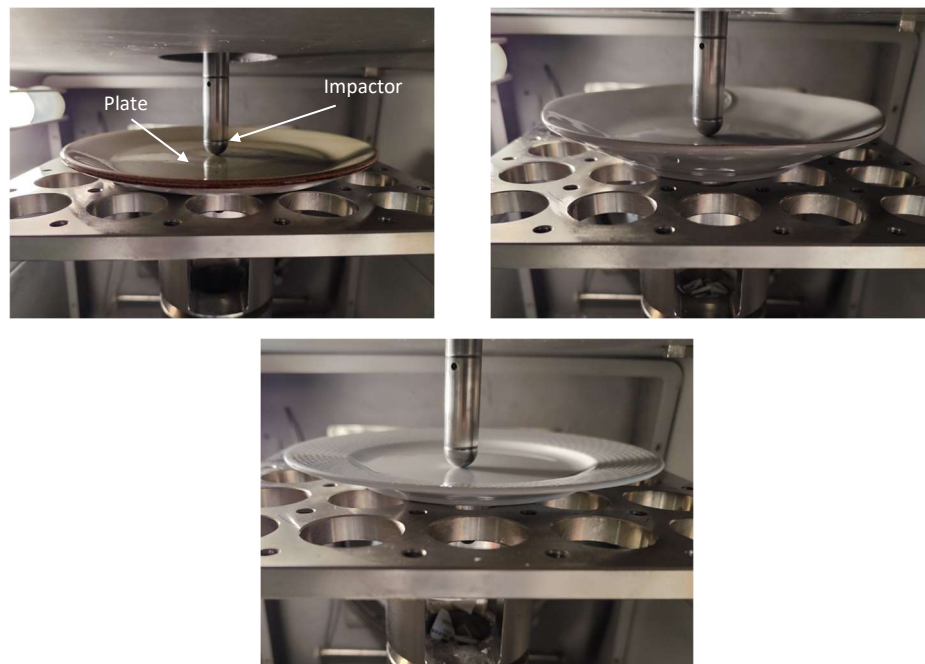
Figure 2 – Test configuration to perform multi-axial impact tests on plates

| Impactor | Hemispherical impactor with a diameter of 20 mm, non-lubricated (Figure 2) |

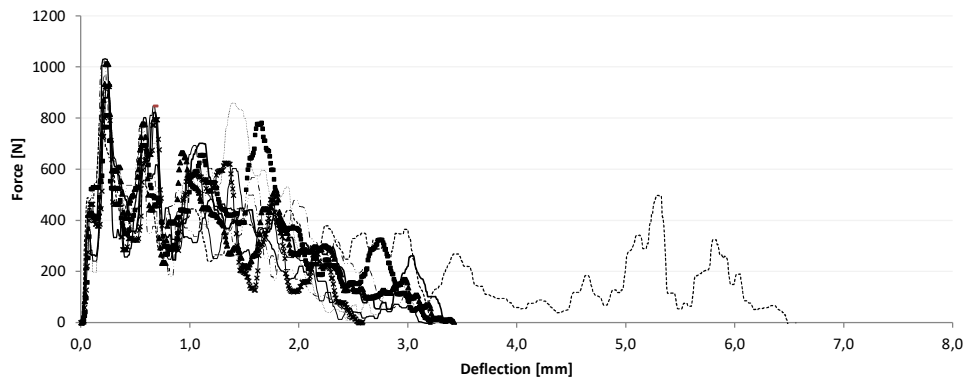
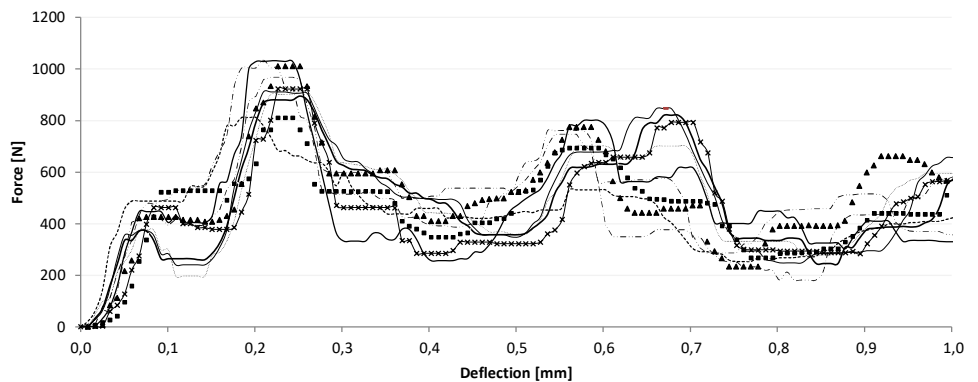
(a) Full-scale axis

(b) Magnification on the x axis

Figure 3 - Curves of force versus deflection recorded in multi-axial impact tests carried out on [REDACTED] porcelain plates

The force *versus* deflection curves recorded in multi-axial impact tests carried out on the plate samples [REDACTED] are shown in Figures 3 to 5. Figures 6 and 7 show the curves obtained with the *StudioNeves* stoneware and bioplastic plates, respectively.

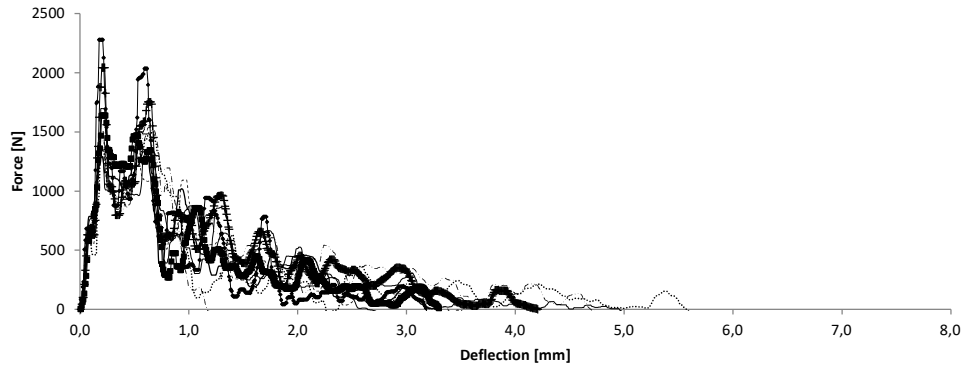
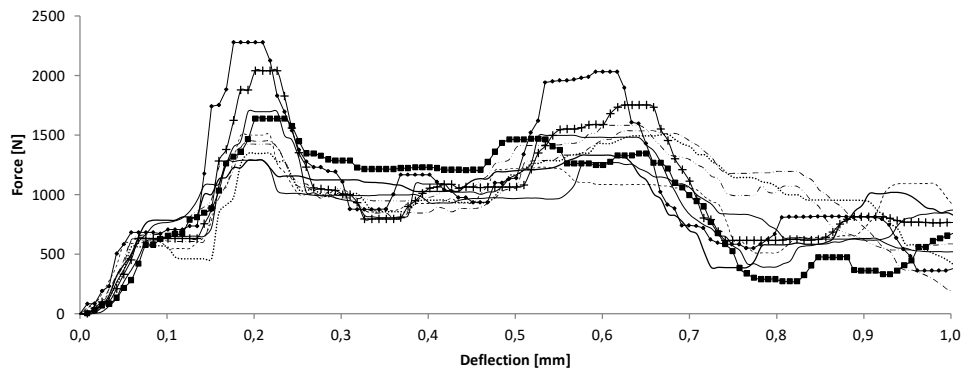
(a) Full-scale axis

(b) Magnification on the x axis

Figure 4 - Curves of force versus deflection recorded in multiaxial impact tests carried out on [REDACTED] stoneware plates

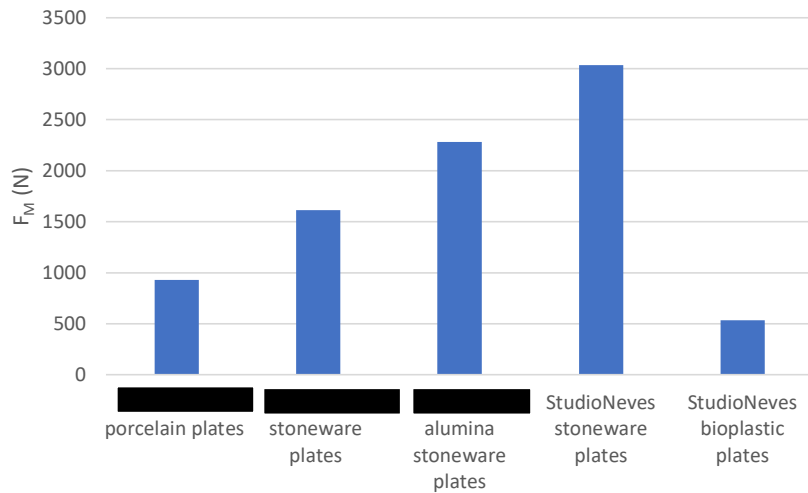
Figure 8 - Maximum impact force (F_M) obtained for samples analysed

The *StudioNeves* stoneware plates exhibit the highest maximum impact force (F_M), which indicates the material's ability to resist initial puncture, followed in decreasing order of maximum impact force by [REDACTED] alumina stoneware (approximately 25 % lower), *Costa Nova* stoneware (approximately 47 % lower) [REDACTED] porcelain (approximately 69 % lower) and *StudioNeves* bioplastic plates (approximately 82 % lower), as shown in Figure 8.

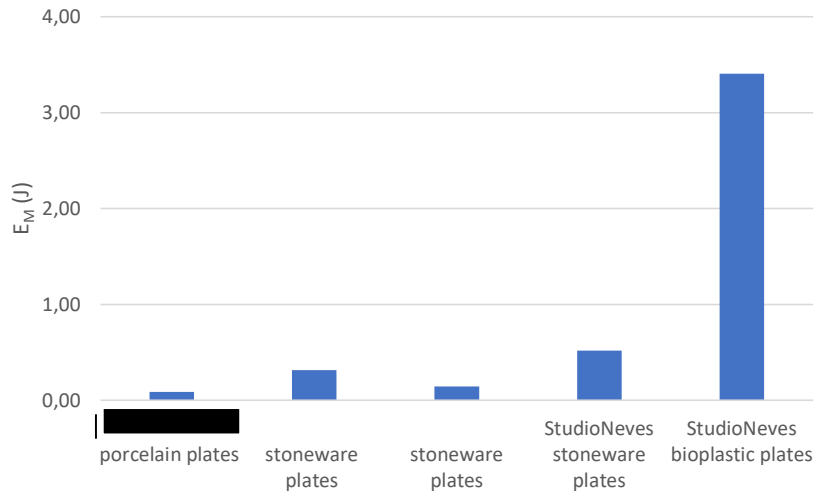
Figure 9 – Energy at maximum impact force (E_M) obtained for samples analysed

Concerning impact energy, which reflects the material's ability to absorb energy (E_M) and resist crack propagation (E_p), *StudioNeves* bioplastic plates exhibit a notably higher value (Figures 9 and 10). The energy at maximum force (E_M) of the *StudioNeves* bioplastic plates is about 7 times greater than that of *StudioNeves* stoneware plates, 11 times greater than that of [REDACTED] stoneware plates, 24 times greater than that of *Steelite* alumina stoneware plates and 40 times greater than that of [REDACTED] porcelain plates.

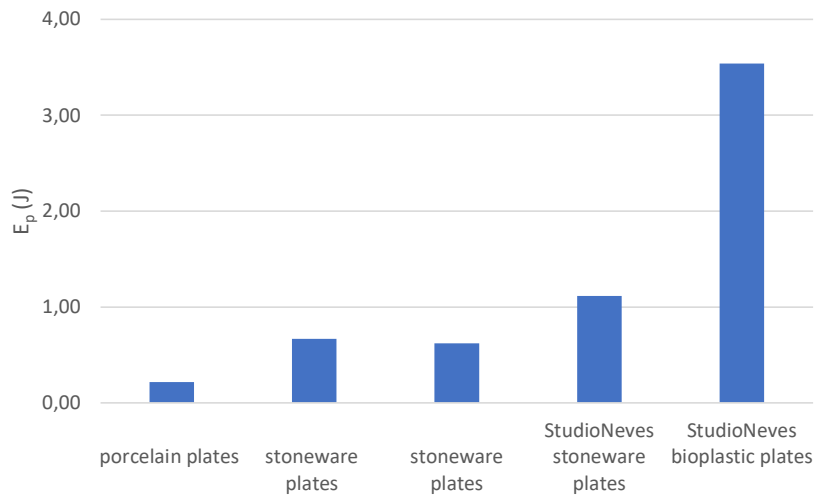
Figure 10 – Puncture energy (E_P) obtained for samples analysed

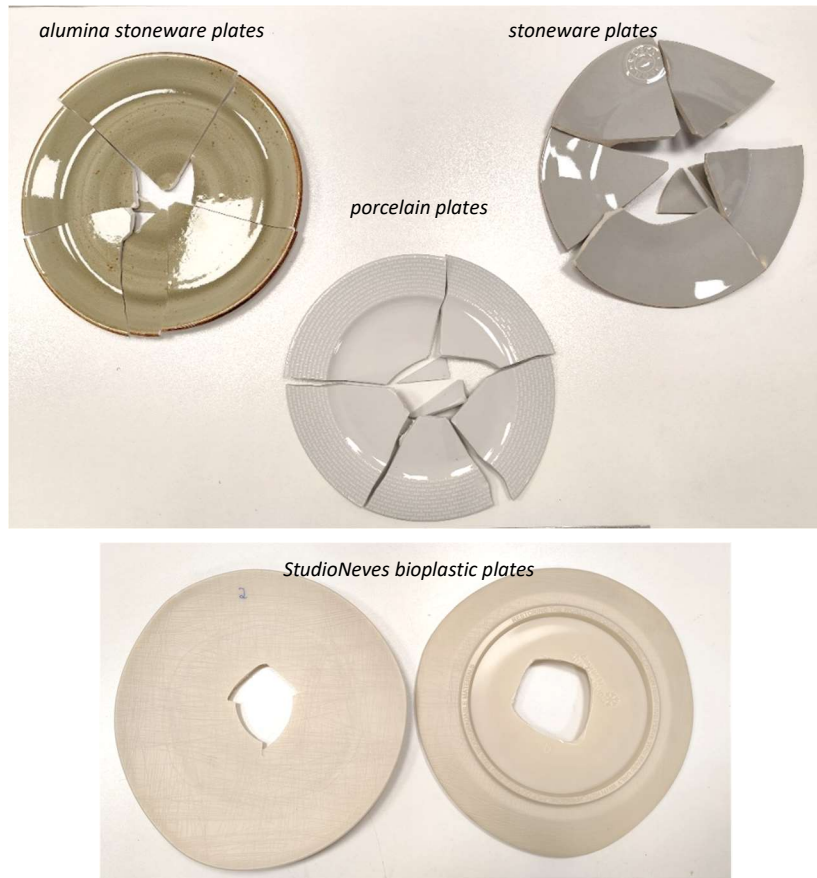
Figure 11 - Failure mode observed in plate samples subjected to multi-axial impact tests

The reduced ability to absorb and dissipate impact energy effectively makes *StudioNaves* stoneware, [REDACTED] porcelain plates more susceptible to cracking (once a crack is initiated, it can rapidly propagate through the material, leading to catastrophic failure), as shown in Figure 11.
